## **Visual Inspection in Dilapidation Study of Heritage Structure Using Unmanned Aerial Vehicle (UAV): Case Study As-Solihin Mosque, Melaka**

**Keywords:** UAV, dilapidation study, heritage building,

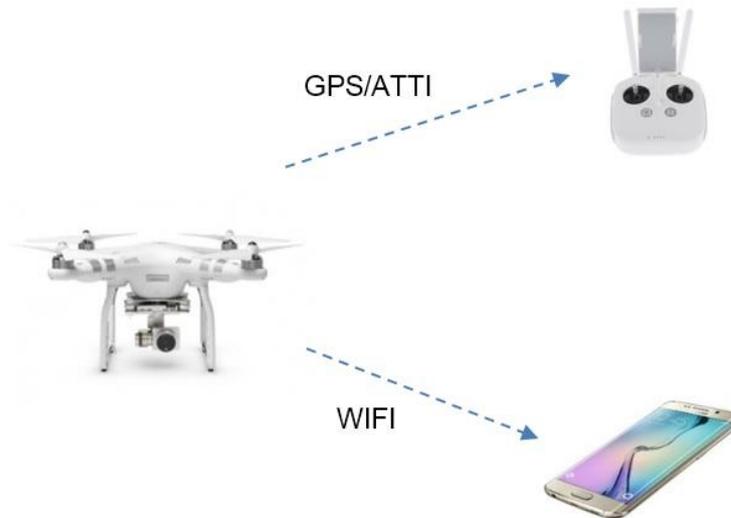
Micro UAV DJI Phantom 3 Advance is used in this study to produce photos and videos of the outer section of the As Solihin, Sebatu mosque's roof. This particular UAV can fly in less than an hour and have limited load capacity factor. The UAV design is based on glider aircraft and could only carry a small but light camera. Even though this micro UAV can fly up to 10,000 feet horizontally, in terms of capturing aerial images, the optimum image quality can be captured between 800 to 1,200 feet while having a resolution of 6 cm to 15 cm per pixel. DJI Phantom 3 Advance is equipped with a camera that can capture both photos and videos using its 12 Megapixels Sony 1/2.3 inch CMOS sensor with 20 mm lens (35 mm equivalent) f/2.8. The visuals can be projected through a smartphone that has installed DJI Go App. According to Mohd Zambri (2012), it is built with a smart camera which supports 720p 30 fps HD and can be controlled by iOS or android devices. A MicroSD card with a capacity of 64GB is used that can store both videos and photos. The software can be downloaded through App Store or Google Play that should connect with the camera. The application connects the smartphone and the UAV through Wi-Fi connection. By using DJI Go application, the camera's functions can be controlled through the smartphone (Figure 1).

**Figure 1:** Communication Between Remote Controller, DJI Phantom 3 Advance dan Smartphone

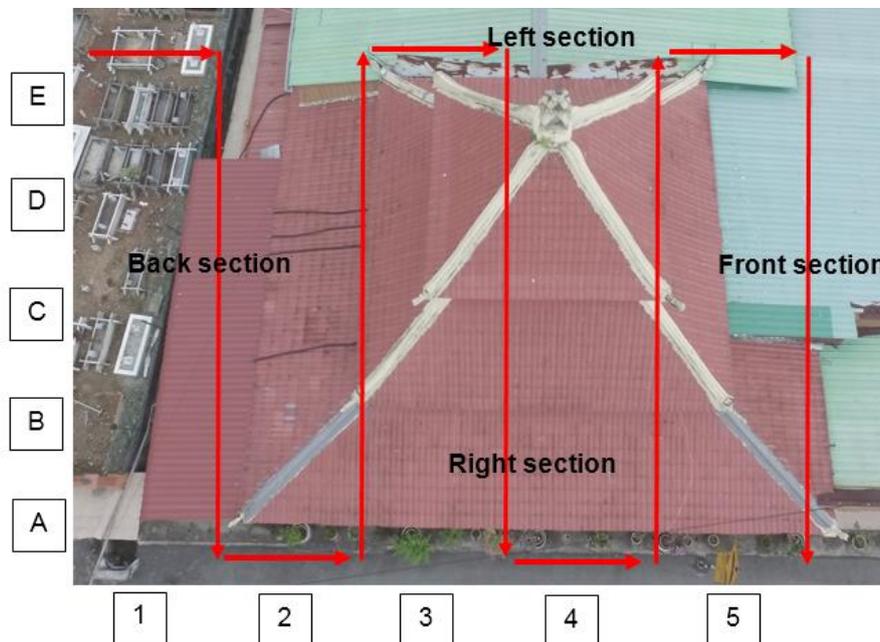
According to Masiri (2016), the distance between the UAV and the building must be 2 meters or less while flying to produce clear quality recordings. In this study, grid concept is used as reference to identify the location of damage and defects. According to C. Eschmann (2012), the flight path of the UAV has to be vertical to get a clearer visual. The roof section is divided into 4 regions; front, back, left and right. The flight path is as Figure 2 to cover all area of the roof. The type of damage to be recorded is referring to the checklist of defects in the Heritage Building Conservation Guidelines, State Heritage Department 2012.

**Figure 2:** Flight direction according to roof section

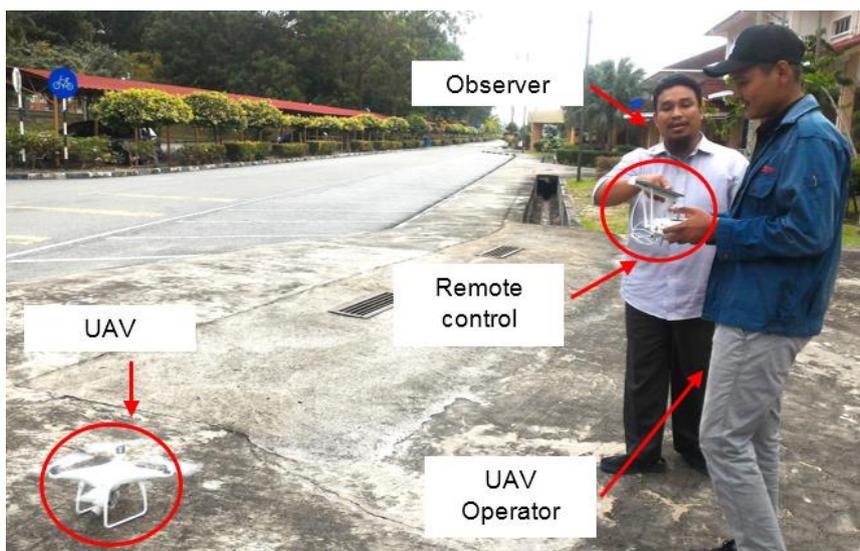
Data collection involves video footages and images of the mosque's exterior roof structure by using UAV. The whole roof area is recorded as in Table 1. During the process of data collection, the UAV pilot collaborates with an observer to maintain the 2 meter distance from the roof. The task of an observer is to guide the pilot on the whereabouts of the UAV. The observer is responsible in avoiding any collision between the UAV and the mosque's structure by giving proper instructions to the pilot. At least two persons are involved during any data collection process. Figure 3 refers to the observer and the pilot for this study.

**Figure 3:** Data collection process

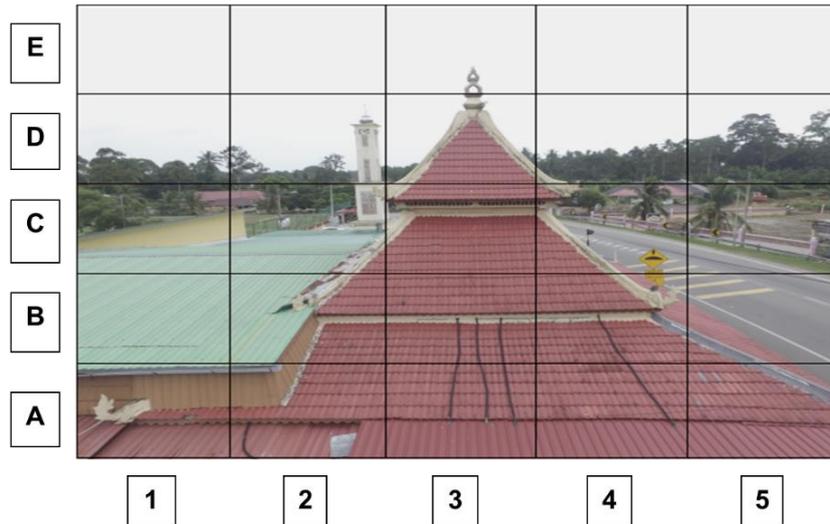
Images are extracted through video footages that have been captured on the overall structure of the mosque's roof. Every image that has been produced will be processed and analysed based on the sections divided into grids (Figure 4). More detailed analysis is performed at any defective or defective location to obtain a clearer picture of any damage occurring. The zoomed image will be analysed using Adobe Photoshop. This study has taken the amount of damage or defect that has experienced over 5 times as a sample.

**Figure 4:** Section of roof divided into grid

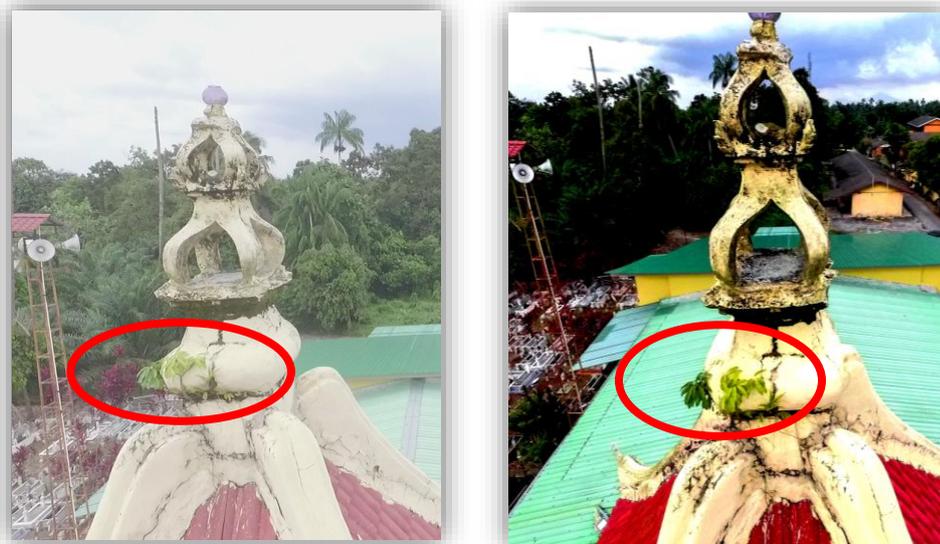
Adobe Photoshop is used to produce better images and easier to identify the type of defect the structure is currently having (Figure 5).

(i) Before editing

(ii) After editing

**Figure 5:** Editing of photo image before and after using Adobe Photoshop

Each image has different techniques depending on the image and type of damage that occurs. Structural damage caused by plants is identified using *Diffuse Glow* and *Find Edges* technique. To identify the types of corrosive surface damage, *Craquelure* and *Grain* technique analysis are used. Damage such as rusty and decay structures uses the technique of *Brush Strokes Accented Edges*. There are several other analysis techniques used to detect different types of damage to the outer structure of the mosque's roof.

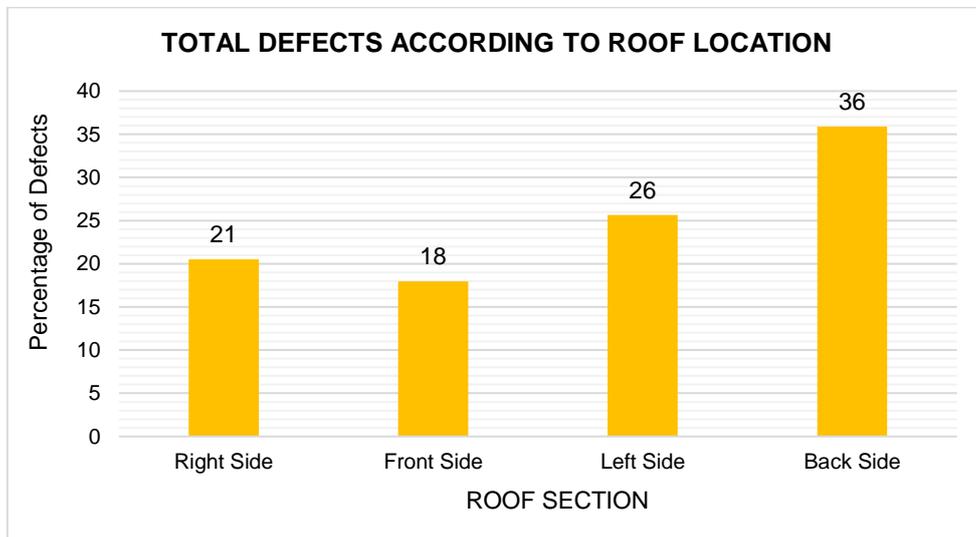
From the results shown in Figure 6, it is clear that the back side of the roof has the most defects which is 36% while the front side of the roof has the least amount of defects which is 18% of the whole amount of defects of the roof.

**Figure 6:** Graph of total defects according to roof location

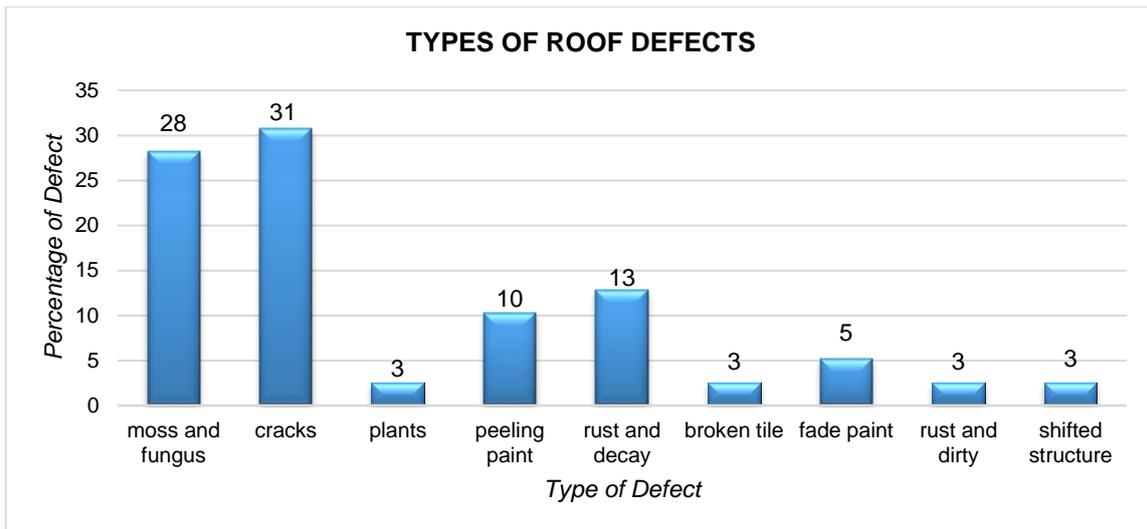
A few type of defects on the roof have been identified such as moss and fungus, cracks, plant infested, peeling paint, rust and decay, faded paint and others. The graph in Figure 7 clearly shows that cracks on the exterior structure of the roof having the most effect at 31%, followed by moss and fungus at 28%. Plant infestation, cracked roof tiles, shifted structure, rust and dirty are minor defects detected on the roof.

**Figure 7:** Graph of total roof defects according to defect types
