# The Effect of Timber Joist Hanger Depth and Width to its Shear Strength (Balau Species)

**Abstract:** *In this paper, the shear strength behaviour of timber joist hanger from Balau species for different depth and width was studied. It was found that the maximum capacity of the joist hanger for 60mm, 120mm & 180mm depth was 11.79kN, 21.85kN & 40.93kN respectively until the hangers failed with different size of failure mode based on the depth with the percentage of 46.0% between 60mm & 120mm depth and 46.6% between 120mm & 180mm depth. The maximum capacity of the joist hanger for 35mm & 50mm width are 11.79kN & 13.91kN respectively until the hangers failed with different size of failure modes based on the width with the percentage of 15.21% between 35mm & 50mm width. The comparison of failure mode behavior of the joist hanger between different depth and width shows the same failure mode for the specimens with different size of failure based on the lower depth to higher depth and lower width to higher width. The depth and width of the hanger have a significant effect on the connection. Thus, the size contribution does affect its shear strength capacity and Balau hanger application.

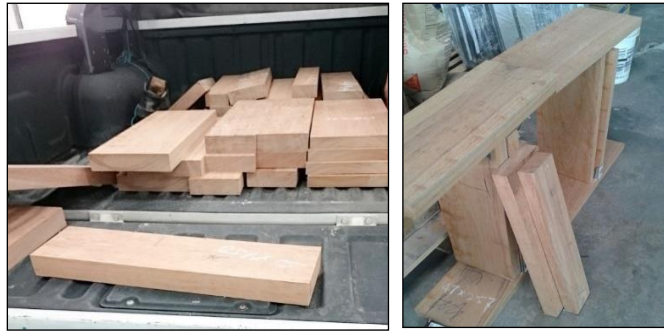
**Figure 1: Timber from Balau species**

The hard, heavy timber species of Shorea occurring in south East Asia are grouped under common trade names peculiar to the area. Thus Selangan Batu (Hard Selangan) is the name used in Sabah, Brunei and Sarawak, while Balau is used to describe the heavy Malaysian species. Balau is generally separated into two types in Malaysia that's Balau and Red Balau. Balau is produced mainly from Shorea Atrnervosa, shorea Elliptica, Shorea Foxworthyi, Shorea Glauca, Shorea Laevis, Shorea Maxwelliana and Shorea Submontana. Balau is a yellow – brown or reddish – brown timber with interlock grain and a moderately fine and even texture. It is classified in Malaysia as being very durable. Density at 19% moisture content for Balau timber is 1000kg/m<sup>3</sup> (MS544: Part 2:2001). For strength groups of timber in naturally durable, Balau was categorized in S.G.1 (MS544: Part 2:2001). Balau is highly durable hardwood native to Malaysia, Indonesia and the Philippines, used mainly for heavy construction. Figure 1 illustrates the timber Balau species.

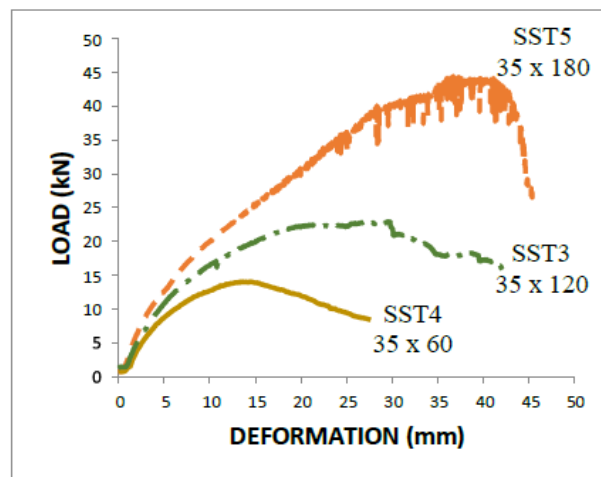
Figure 2: Joist hanger with different depth (60mm, 120mm & 180mm) but same width (35mm)

After the completion of testing works, the overall results were described through the graph diagrams. Five of the ten graphs have been chosen to be analysed for average maximum load from different width and difference depth. From Fig. 2, it was observed that hanger for 35 x 180mm recorded the maximum load of 40.93kN followed by 35 x 120mm width with maximum load of 21.85kN and 35 x 60mm, 11.79kN. The graph for 35 x180 has shown that the vertical line during the load increase until the sample failed. This is due to the joist hanger plate was failed together with joist timber. For the observation, the top of joist timber was crushed. It occurred because both of materials have a strong grip connection.

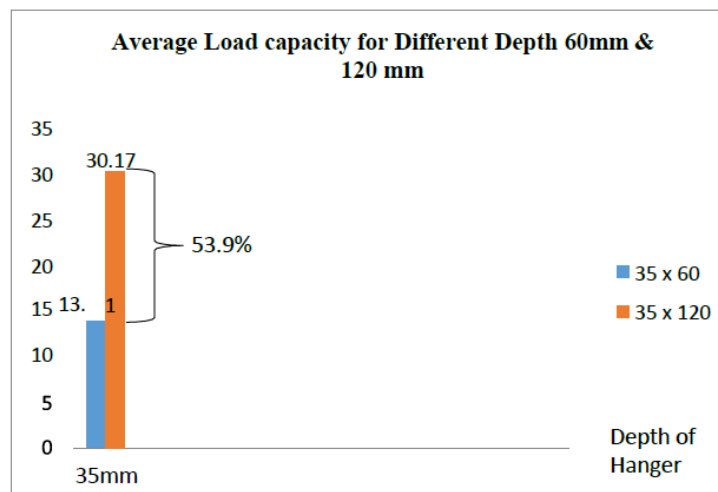
Figure 5: Percentage of load capacity of joist hanger with different depth (60mm & 120mm) but same width (35mm)

Figure 4 shows a graph with a similar pattern like Figure 2 and the hanger for 50 x 120mm recorded the maximum load of 32.54kN and the hanger plate was torn after it reached the maximum value of load capacity. The graph line for 50 x 60mm shows that the maximum load of joist hanger is 14.6kN which is less than 50 x 120mm. The hanger of 50 x 60mm is not suitable to carry the connection for heavy structure. Figure 5 shows that the percentage of load capacity for different depth (60mm & 120mm) but the same width (35mm). The percentage recorded was 53.9%.

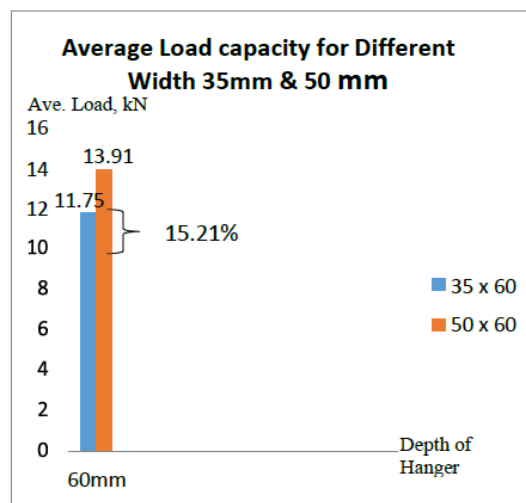
Figure 7: Percentage of load capacity of joist hanger with different width (35mm & 50mm) but same depth (60mm)

Figure 7 shows the graph of average maximum load from different width. It was observed that the load of the hanger for 50 x 60mm is higher than hanger size of 35 x 60mm. Then, the graph suddenly decreases drastically but it increases again before slowly dropping. It happened because during experiment, the hanger plate 50 x 60mm was torn after it reached the maximum load. But the graph is going up after plate torn because the connection still has a strong grip between joist and hanger. Finally, it was slowly dropping until failure.

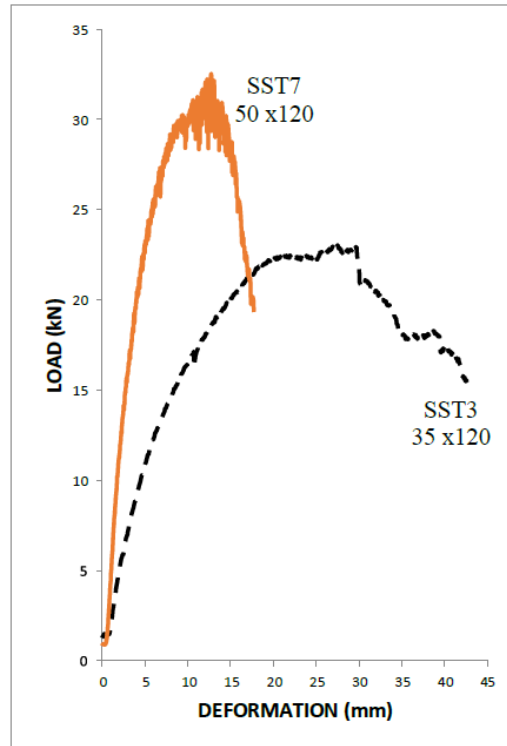
Figure 8: Graph joist hanger with different width (35mm & 50mm) but same depth (120mm)

Figure 8 shows that the graph of joist hanger with difference width (35mm & 50mm) but same depth of 120mm. The graph described that the load of hanger for 50 x 120mm was higher than hanger size for 35 x 120mm and also decreased drastically after it reached the maximum load. While for hanger 35 x 120mm was slowly increasing and slightly decreased until the joist hanger reached the failure mode.

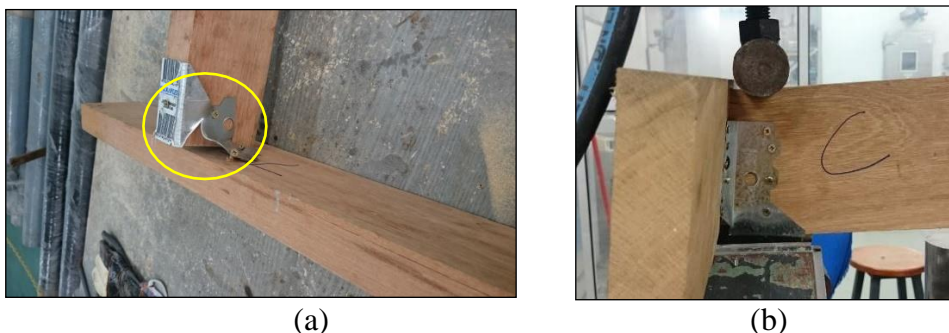
Figure 9: (a) Failure on joist hanger for sample SST1 (b) Failure on joist hanger for sample SST2

From the experiment, the failure mode for the samples has been analyzed; it can be seen that the failure mode was typically of the same condition which failed on joist hangers. The same condition is meant for the tear pattern of the joist hanger. The tear pattern was displayed in figures below. The Figure 9(a) showed that the failure mode of joist hanger for size 35 x 60mm depth. The pattern of failure was initiated by the torn. From the observation, the large torn was obviously due to the size of timber joist that cannot grip the hanger as strong as possible during the load applied.

Figure 9(b) and 9(c) displayed the sample of joist hanger for size 35 x 120mm depth. From the observation, the deformation can be viewed on top of the connection. The hanger initiated to torn in slowly mode. In Figure 9(d) shows the joist hanger for size 35 x 60mm depth tested in laboratory. From the testing result displayed, the hanger failed in edge of hanger plate and after that it failed at each point of bolt location. From the observation, the hanger cannot resist the timber joist for large load. It is because the timber joists do not have any crush on top of the timber surface which means timber joist showed that it has a good strength performance for this particular hanger size.

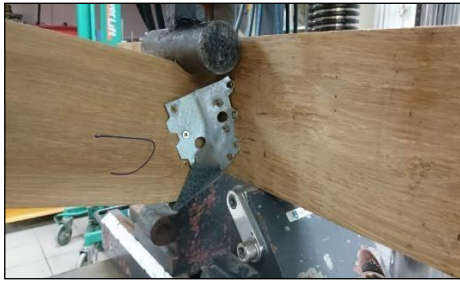
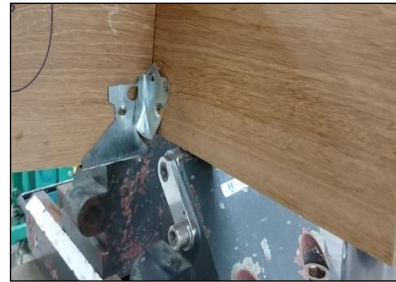
**Figure 9: (c) Failure on joist hanger for sample SST3 and (d) Failure on joist hanger for sample SST4**

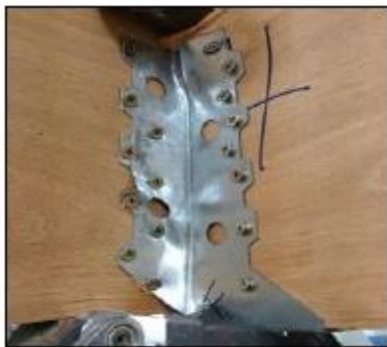
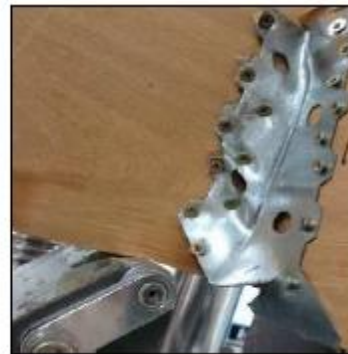
**Figure 9: (e) Failure on joist hanger for sample SST5 (f) Failure on joist hanger for sample SST6**

Figure 9(e) shows the sample joist hanger for size 35 x180mm depth. From the observation, the failure can be viewed on top of the connection. The hanger started to tear slowly. When the load applied, it disturbed the joist timber surface. As the figure shown, the top of timber surface was crushed, and the hanger plate was dented due to the compress load. In Figure 9(f) shows the sample joist hanger for size 35 x180mm depth. From the observation, the failure can be viewed on top of the connection. The hanger started to tear slowly. When the load applied, it disturbed the joist timber surface. As shown by Figure 9(f), the top of timber surface is the same as Figure 9(e), it was crushed, and the hanger plate was dented due to the compress load. At the bottom also show that that joist hanger was torn at the edge of hanger.

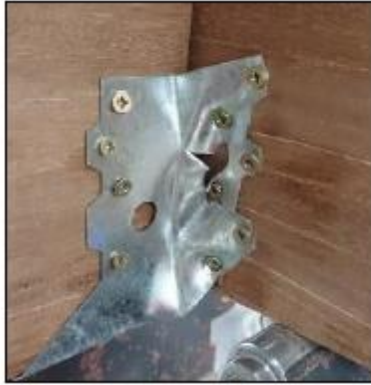
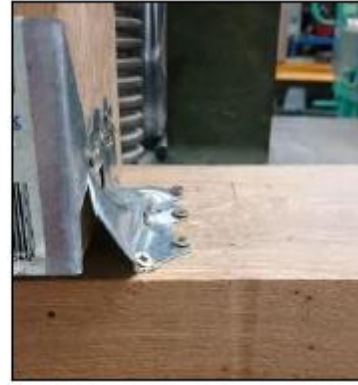
**Figure 9: (g) Failure on joist hanger for sample SST7 (h) Failure on joist hanger for sample SST8**

Figure 9(g) shows the sample joist hanger for size 50 x120mm depth. From the testing, the failure can be viewed at the joist hanger, between the bolt locations. The hanger started to torn at the bottom area. From Figure 9(h), 9(i) and 9(j), it displayed the sample joist hanger for size 50 x60mm depth and 50 x 120mm depth. From the observation, the failure can be viewed on the edge of plate at the bottom of joist timber. The hanger started to torn and the bolt began pass out from timber and hanger one by one. There was failure mechanism under the shear test done. The typical failures were shown in the Figures were failure at joist hanger point. The mode of failure that occurred was the hanger being teared apart at an angle.

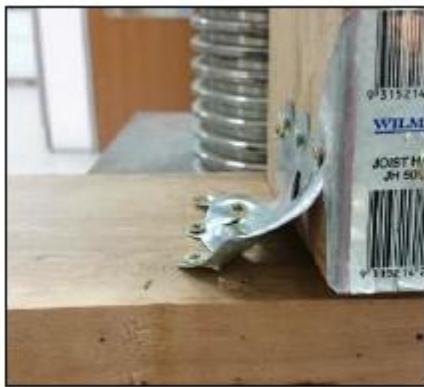
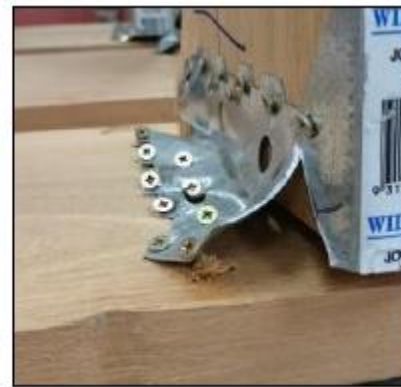
**Figure 9: (i) Failure on joist hanger for sample SST9 (j) Failure on joist hanger for sample SST10**
